DATE: November 2024

TREE CONDITION REPORT FOR Henley in Arden Town Council

AUTHOR: MARK CHESTER

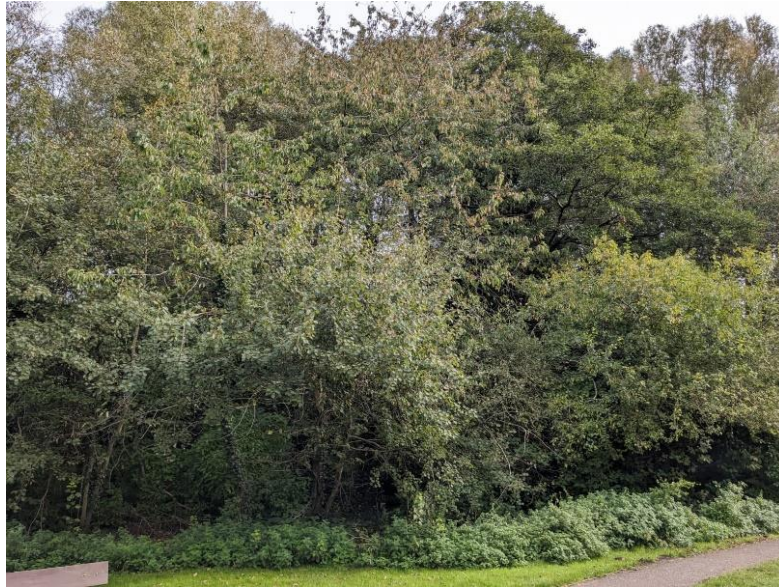
IMAGE 1 (above) A view of the woodland edge.

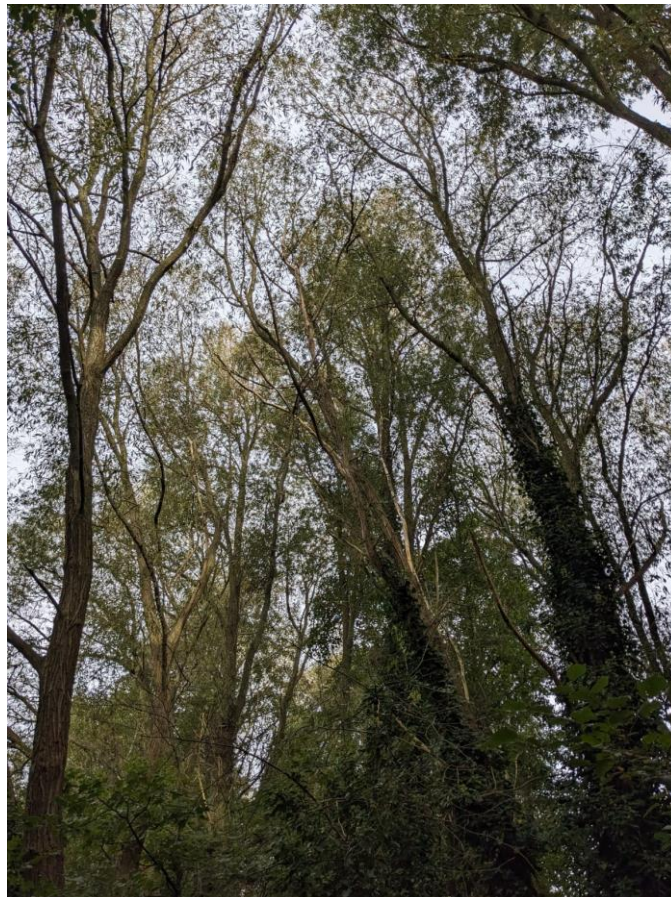
IMAGE 2 (below) Some of the large willows in the woodland edge. They are tall, with extensive dead wood and ivy. Pollarding/coppicing is recommended.

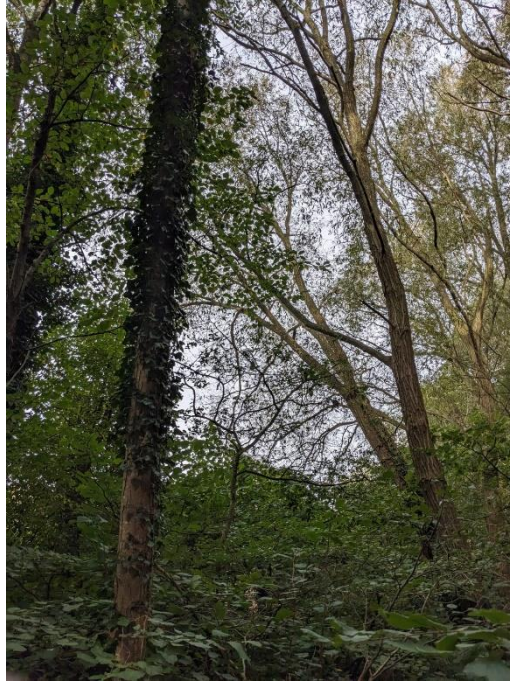
IMAGE 3: Two views of the willows, showing some of the dead wood present.

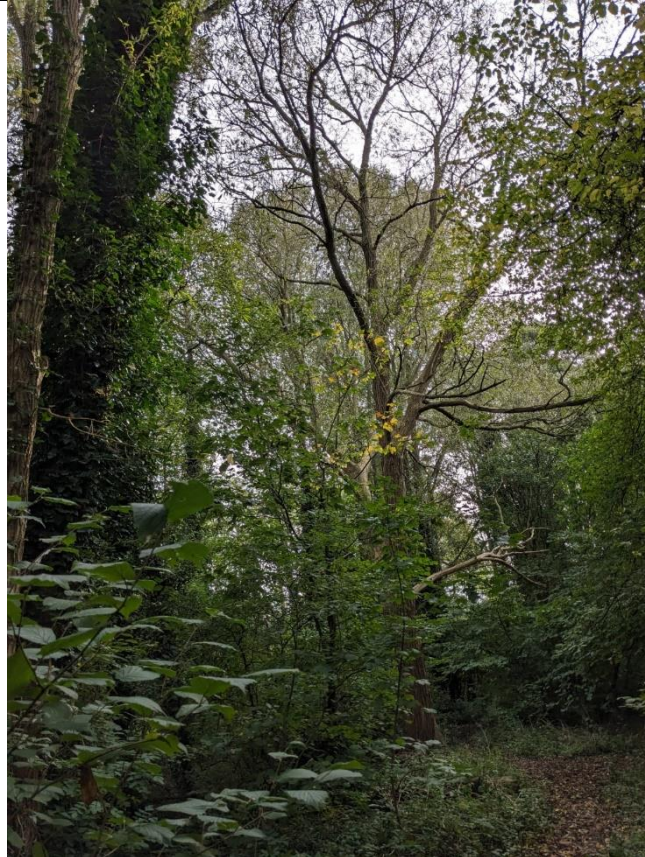
IMAGE 4: Note the lack of ground cover. An improved woodland would include ground cover.

inviting. A good woodland should have ground cover and some smaller trees, which can provide a range of habitats. For example, hazel as a ground cover can provide habitat for dormice and birds. Having some willow as coppice and others as pollards provides a range of habitats, including potentially standing dead wood, which is important for a range of species of fauna and flora.

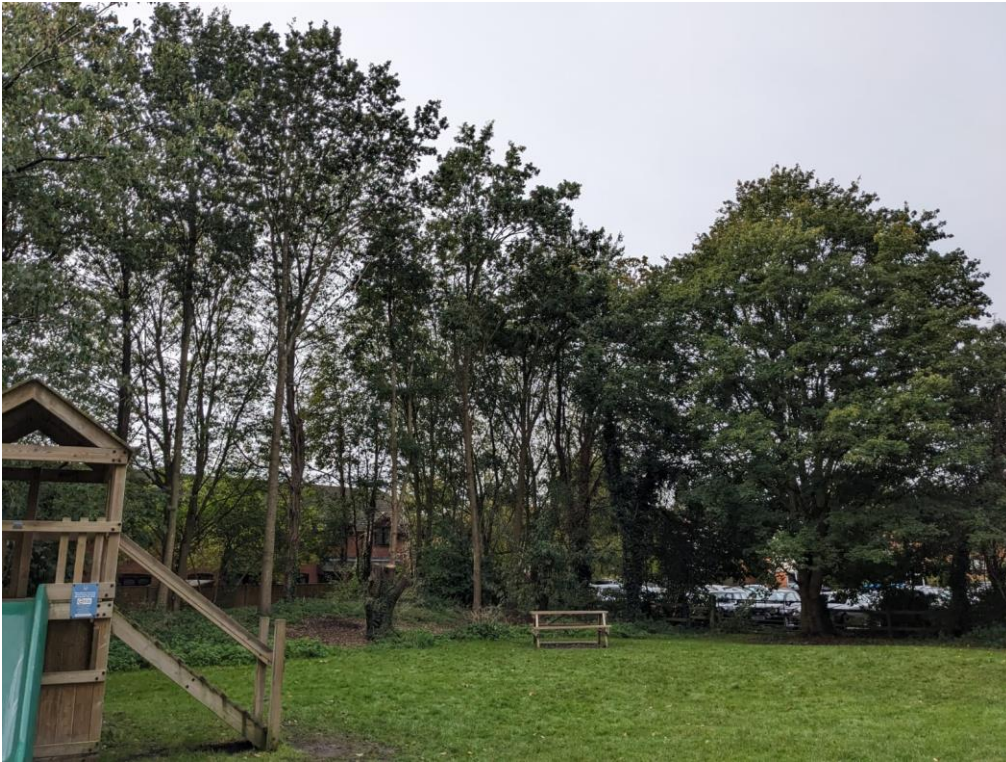
Image 5 Above: Some of the trees in area 3. The oaks are tall and close. They are not screening the houses beyond, but are shading the gardens.

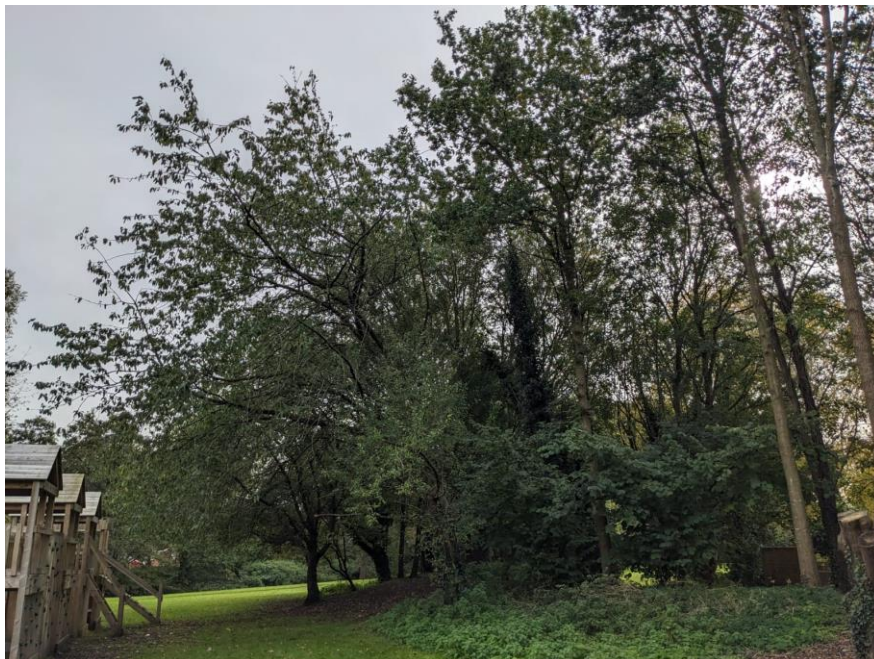
Image 6 Below Another view of area 3. There are trees in decline and some over the play area, which is not ideal.

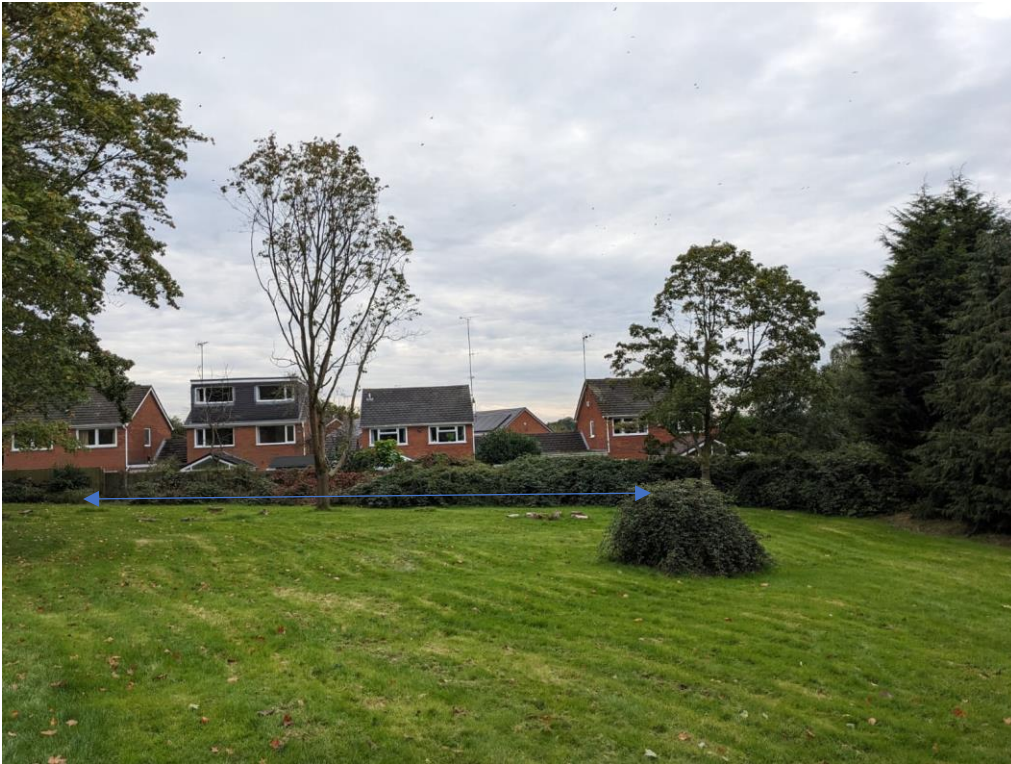
Image 7 (above): Jubilee Park, looking south. About ten trees have been felled in the blue area. There is
Image 8 (below): The woodland edge by the play area. This has not yet been surveyed.

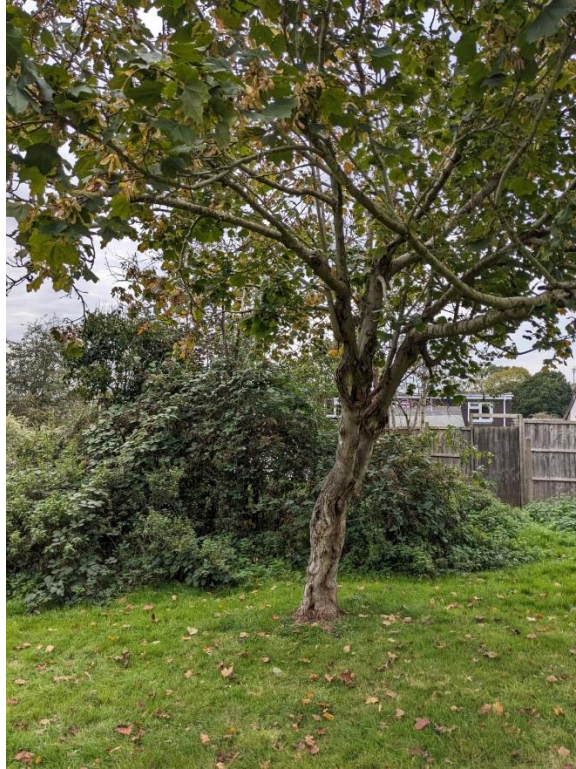
Image 9 (above): One of the trees at Jubilee Park, which is in decline.
Image 10 (below): A tree has been planted at Jubilee Park. The grass around the base will make it difficult for this tree to become established. A more planned approach is proposed.

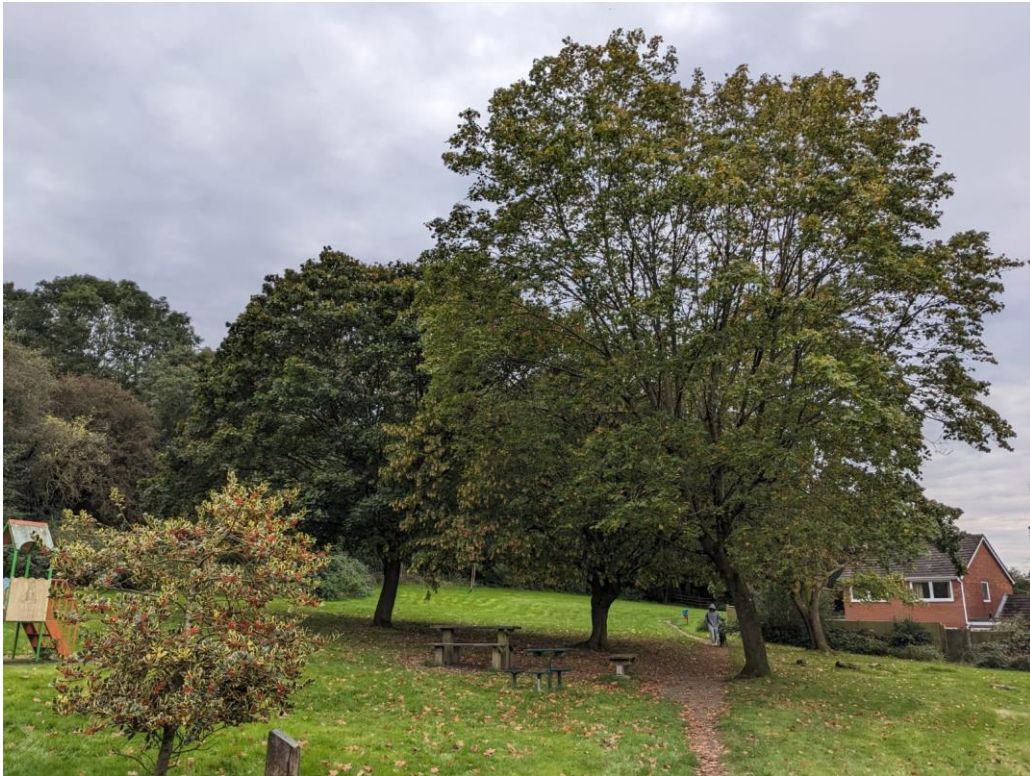
Image 11 (above): Some of the maple trees at Jubilee Park. These are visually prominent. They are not native and offer limited wildlife value.

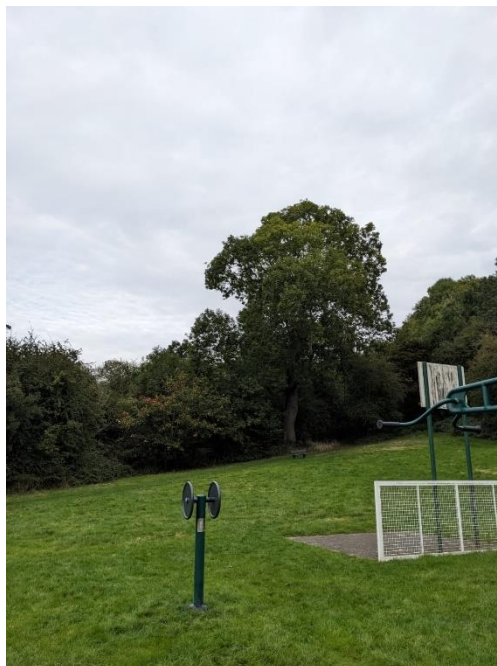
Image 12 (Below): The ash tree on the boundary at Jubilee Park. A more detailed assessment is recommended.
