Flooding of gardens in Castle Close from Jubilee Park.

A Report by Cllr McCaskie 5th of March 2024

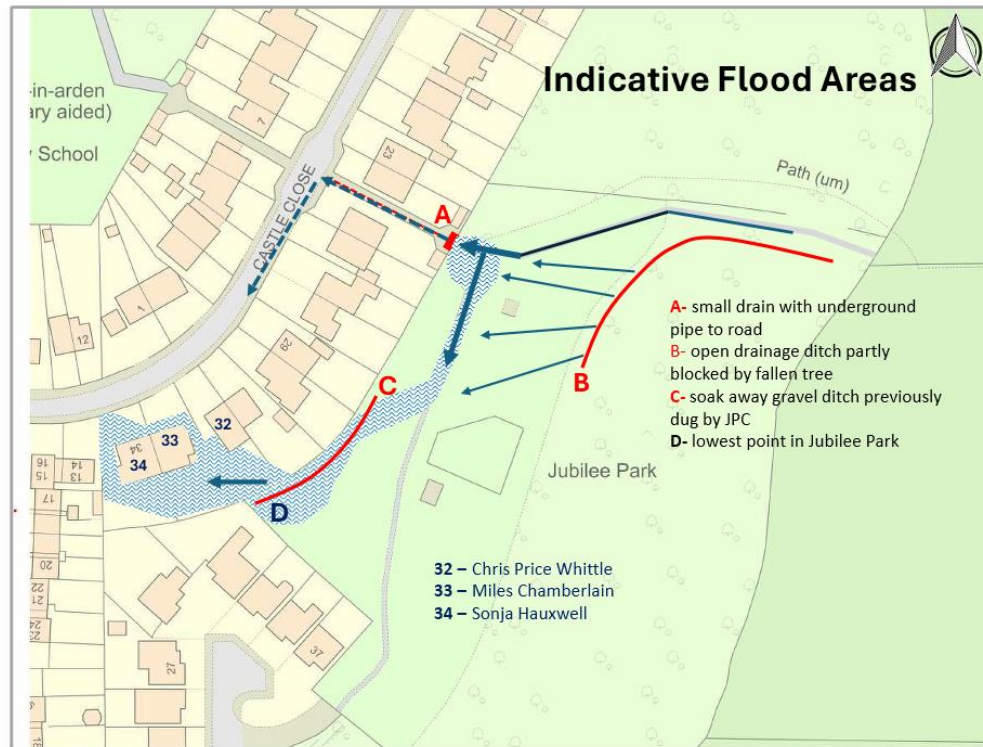
1. Jubilee Park and current surface water drainage
2. Above with surface water flow when ground saturated and heavy rainfall.
3. Above with Indicative flood areas.

A- Is the location of a small channel drain at the top of the path leading from Castle Close to Jubilee Park that has an underground pipe leading down to the road main drain. The issue here is that being relatively small it struggles to cope with the amount of water that flows down the footpath from the fields above and is easily blocked. This results in a backup of water that then travels down the footpath towards the lowest point "D". My assumption is that WCC own the path leading down from Jubilee Park to Castle Close including the Drain "A" and the pipe leading down to Castle Close underneath the path

B- This is an open drainage ditch that runs down the hill next to the footpath but then turns south along the tree line. My assumption is that this was dug to try and alleviate the amount of water running down the steep path and steps, but it has been partly blocked by a large fallen tree which probably diverts some water back onto the path and towards "A" above. The ditch running along the tree line overflows sending water down the grass slope between the play area and footpath up into the woods. This water then flows partly towards "A" but also onto the path leading from "A" towards "D".

C- This is a gravel filled soakaway ditch that apparently was dug by the JPC quite a few years ago and we can assume was probably due to previous flooding of the adjacent houses/gardens.

To mitigate this, we could lessen the water descending the steps/path to "A" and simultaneously upgrade to a broader, more capable drain at "A". This should decrease the water volume heading to "D" to manageable levels for the soakaway ditch. Additionally, cleaning the open ditch "B" of debris and fallen trees would help diminish the water flow towards "A", promoting better absorption into the ground and preventing overflow towards points "A" and "D".

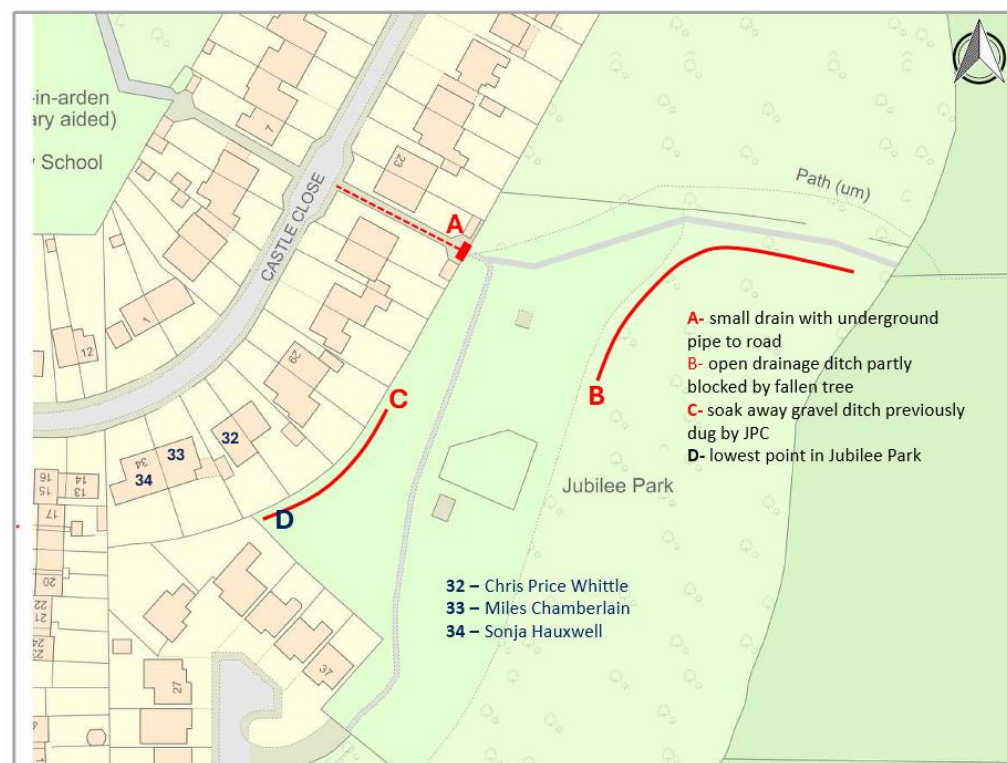
Ultimately, the inability of point "A" to handle the water from the steps/path and the grassy area from "B" leads to the water being redirected towards "D". This contributes to the water that's already descending the grass slope. Consequently, a significant pool of water accumulates at "D" because the existing soakaway ditch "C" is overwhelmed by the water volume.

The problem appears to be the excessive water flow to point "D" from "A" because the current drain is overwhelmed, causing water to reroute to "D". This exacerbates the situation as water already flows down from the woods and the open ditch "B" to that point.

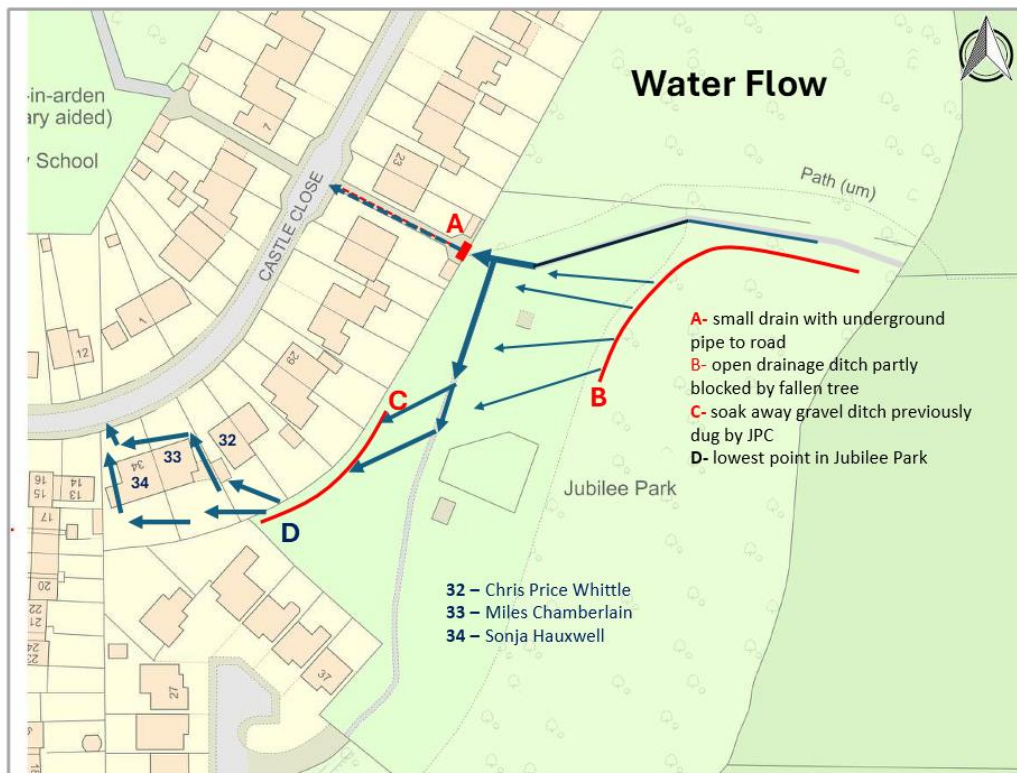
This overflow then passes through the back gardens and garages of the properties at 32, 33, and 34 Castle Close, eventually emerging onto Castle Close via the driveway of property number 34. The water level, indicated by a tide mark at property number 33, surpasses 4 inches, and water is seen cascading down the garden steps from Jubilee Park.
